PERFORMANCE FORD

TRANSMISSION VAMP

After thirteen years of production, you'd have thought any problems with Ford's B5 transmission would have been ironed out by now. Well, if anyone can tell us Peter Formby can.

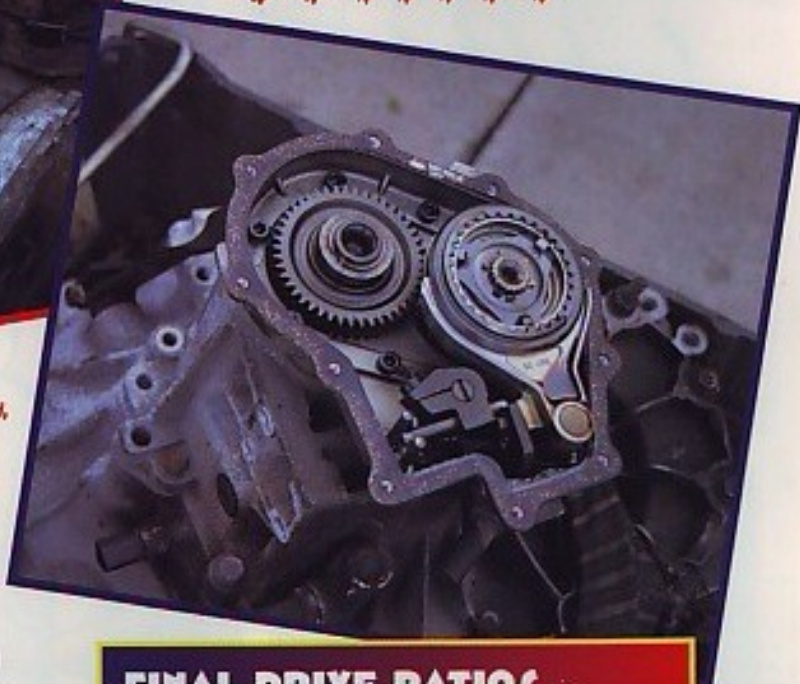
Right: Remove the end cover and check that there is no excess slack in the splines holding fifth gear

1 The input shaft (Lay gear)
The small race bearing at the clutch spline end collapses, causing oil to leak past the front seal (ruining the clutch in the process). And if that doesn't happen, then the other problem is at the other end of the 'box, when the splines at the fifth gear end wear, causing excessive slop and leading to a rattle when the engine is idling - fifth gear should be a very tight

When buying second-hand the gearbox should turn over freely and smoothly, and it should be easy to select all gears. Always remove the tin-plate pressed cover from the main casing and inspect the fifth gear spines, and remove the speedo drive gear and check that over too. ●

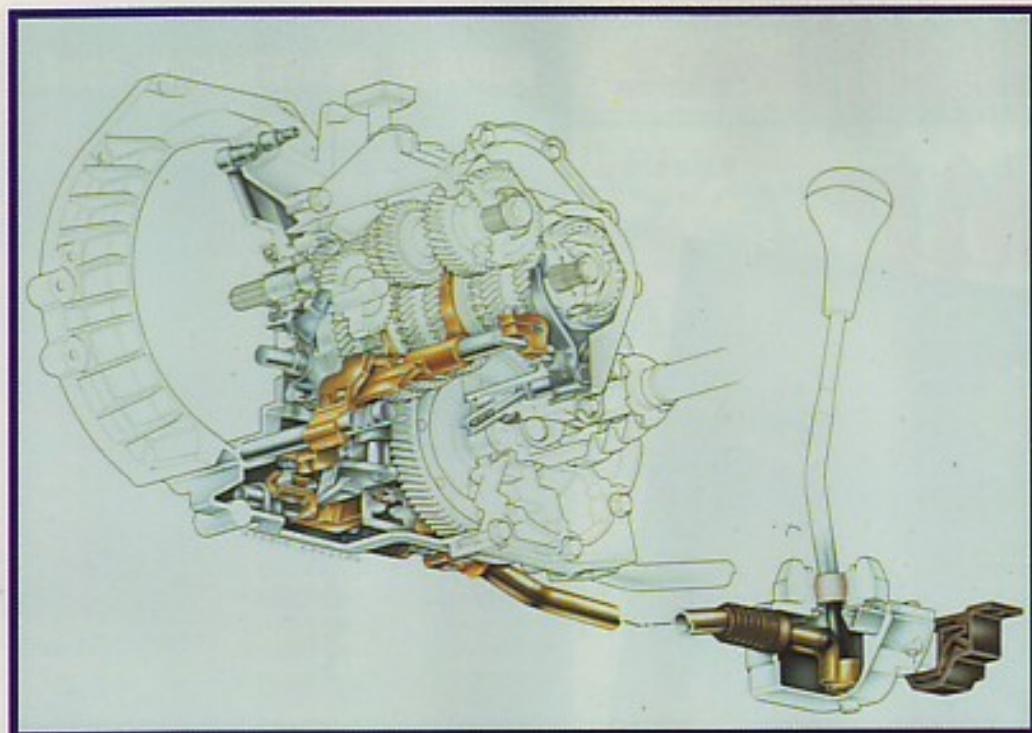
Above: The inside of a B5 gearbox

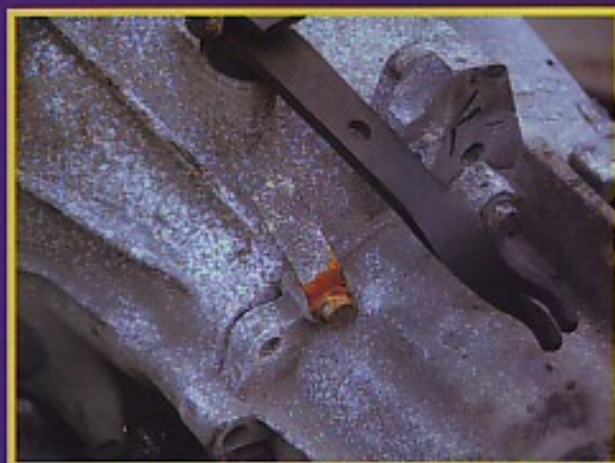
The tag is the ideal way of checking out the contents, but the aluminium is usually pretty badly pitted...

The only guide to the origins of a second-hand 'box is the identification tag that is attached to one of the 13mm bolts which join the two main parts of the casing. This is often corroded but a few minutes spent cleaning and reading it can make all the difference. By reading off the data on the tag (arranged as shown below) and then cross-checking it against our tables, you will be able to tell precisely which set of gears and final drive ratio is in the casing.

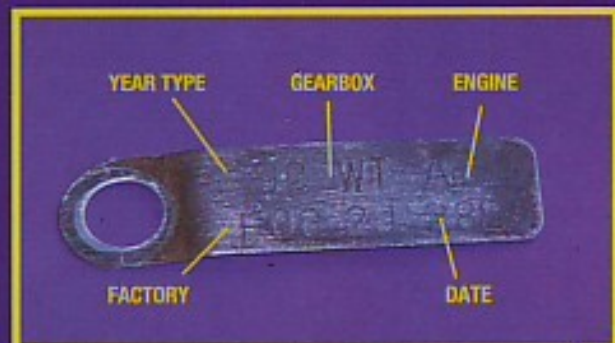
... so it is worth cleaning it off so that the numbers can be read.

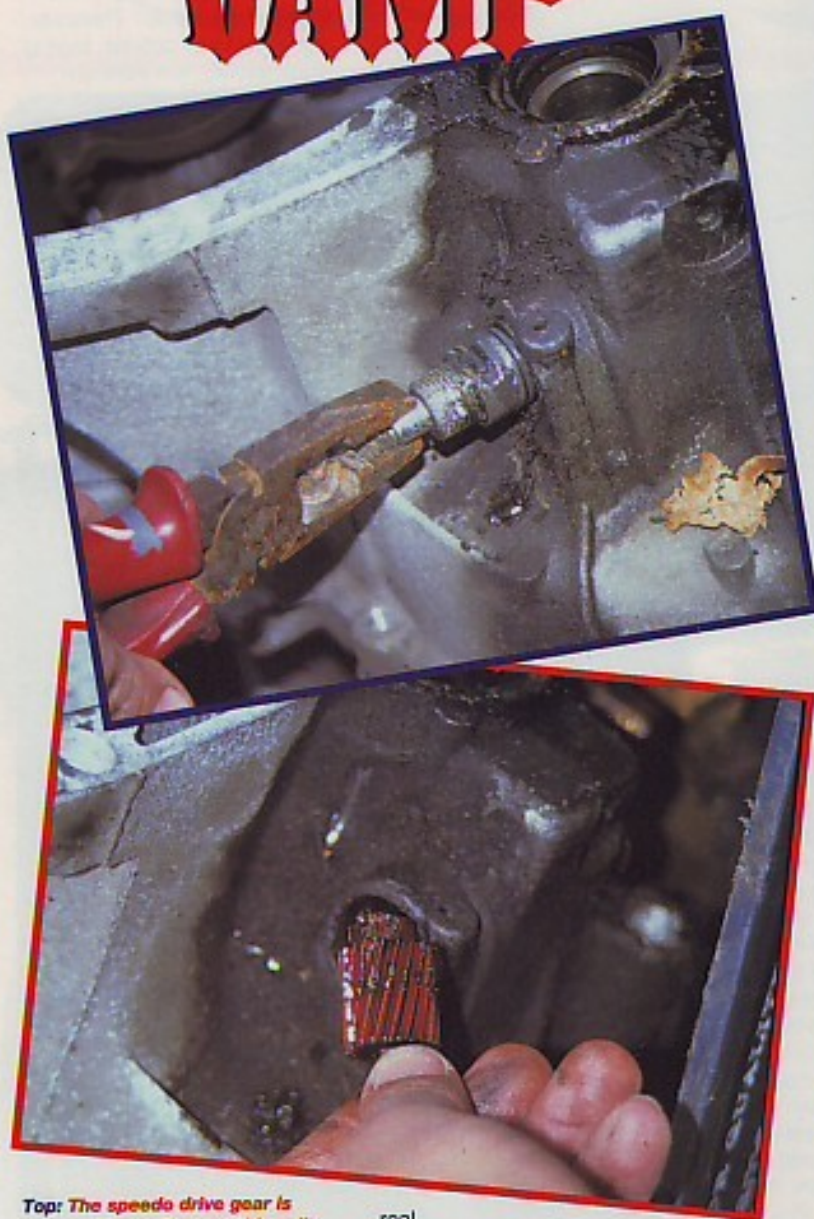
Top: The speedo drive gear is removed by pulling out this split pin...

Above... then gently drawing the outer threaded bush out.
